# HIGH-PERFORMANCE AUXILIARY POWER UNIT TECHNOLOGY DEMONSTRATOR

Avco Lycoming Stratford Division 550 South Main Street Stratford, Connecticut 06497

December 1980

Final Report for Period July 1977 - July 1980

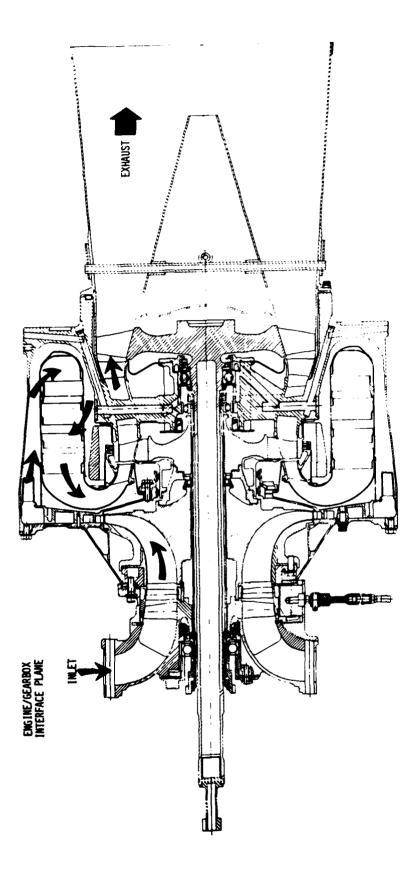
The power producer consists of an air inlet scroll, and gas generator and power turbine modules. The gas generator module includes a single-stage axial, and a single-stage centrifugal compressor. The power turbine module includes a reverse-flow annular combustor and a single-stage power turbine. Overall, the configuration results in a short, compact, engine.

Figure 2. Power Producer.

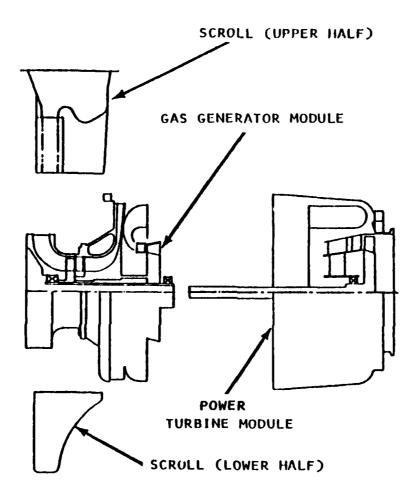
Figure 3. Power Producer Modules.

The inlet and diffuser housings form an integral part of the engine structure and are connected to a gearbox at the front end and the power turbine module at the rear. The inlet housing also supports the forward gas generator shaft bearing with its seal package, and the flow modulator ring and control links.

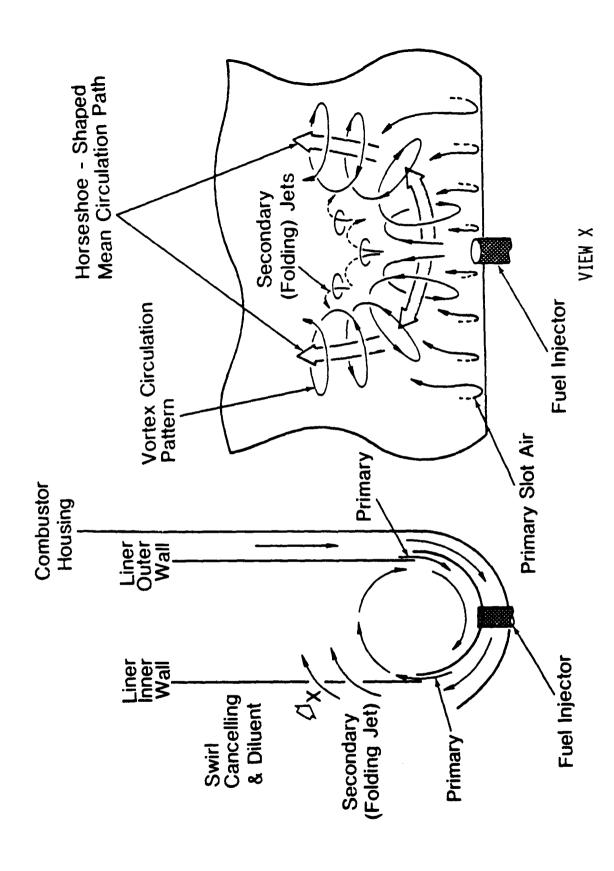
Figure 6. Circumferentially Stirred Combustor Flow Pattern.

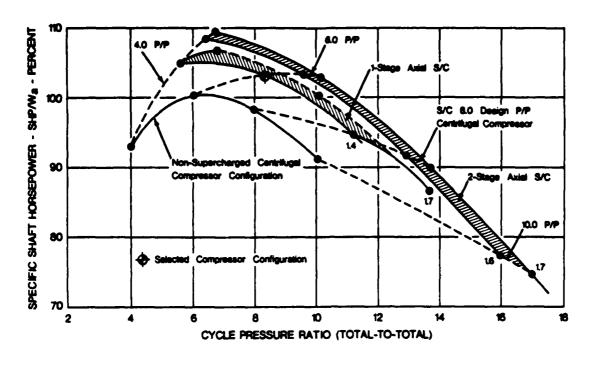
Results in Figure 7 show where specific power and specific fuel consumption are plotted as a function of compressor overall pressure ratio for maximum power points. Separate investigations show that the selection of pressure rise based on maximum power also provide optimum specific fuel consumption values at part load. Three compressor configurations are shown: one centrifugal compressor plus two axial stages of 1.7 pressure ratio. Supercharged configurations are based on centrifugal compressor design pressure ratios of 4, 6, 8, and 10. It is seen that nonsupercharged configurations are low in specific power and high in specific fuel consumption when compared with the more efficient axially supercharged designs at the same cycle pressure ratio.

Relatively high specific power and low specific fuel consumption are obtained for the selected nominal cycle pressure ratio of 8.4 produced by a centrifugal design pressure ratio of 6 and supercharged by a 1.4 pressure ratio axial stage. No significant improvement in specific power is realized by adding a second supercharging stage to the configuration. The specific fuel consumption which improves by about 4 percent would not justify the added complexity of a second supercharger stage at the same cycle temperature.

Figure 7. Five Lb/Sec Parametric Study - Specific Fuel Consumption Versus Cycle Pressure Ratio.

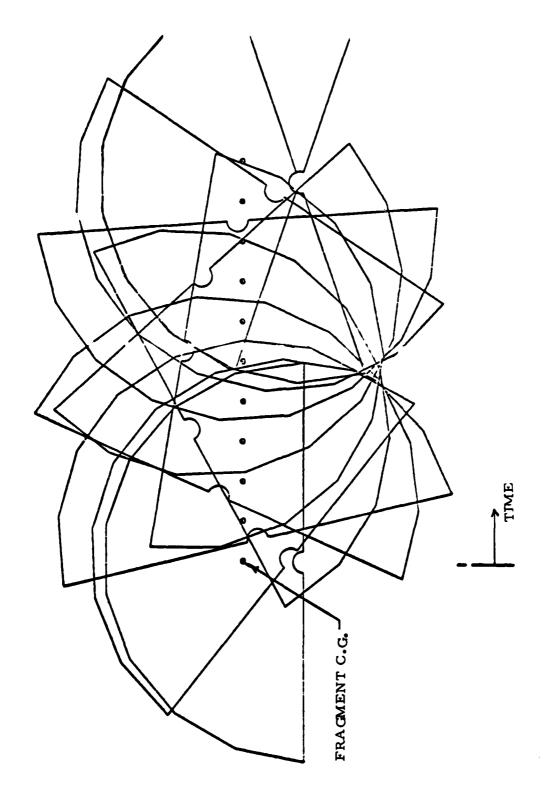
A disc fragment exiting from a turbine stage is illustrated in Figure 14. Here, the initial kinetic energy of the Fragment and its translational and rotational components are computed based on its shape, material, and fracture conditions. Determination of the actively deformed volume of plastically strained material is based on the thickness of the impacted ring, the impact area under the fragment contact surface, and the distance traversed by the plastic stress waves emanating from the impact region during the impact interval. The specific strain energy absorption capacity of the ring material is defined by its stress/strain curve.

Figure 14. Trajectory of One-Half Segment Disc.

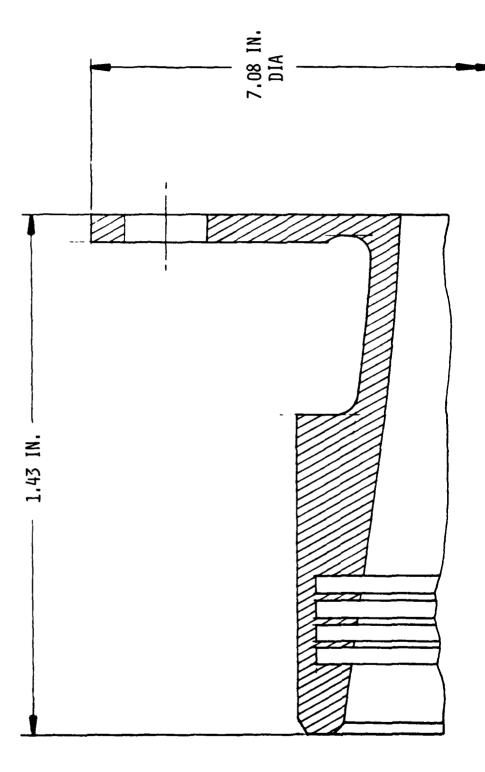
Figure 18. Axial Compressor Shroud.

Details of each containment package are provided as follows: Figures 18 and 19 define the axial and centrifugal compressor shrouding; Figures 20 and 21 show the additional ring that was incorporated over the gas generator turbine; and Figures 22 and 23 cover the circumferential shrouding and axial containment treatment, respectively, for the power turbine. Experience with the basic LTS 101 engine (as well as with the T55-L-11) has proven an exhaust nozzle and centerbody that are effective in restricting aft displacement of the power turbine rotor in the event of shaft failure. It also is effective in the control of axially ricocheting debris from shed blades. Consequently, it is a major benefit in the overall containment design assessment.

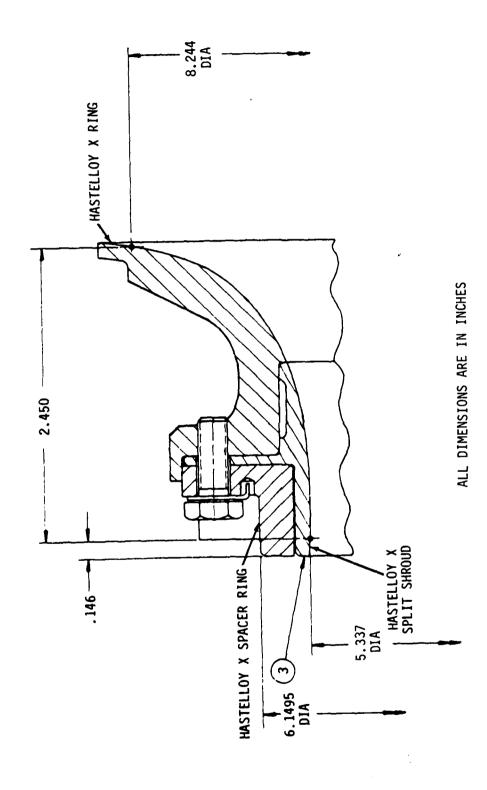
The impeller is also cast. A three-piece shroud, made from Hastelloy X forged rings, provides containment for the centrifugal impeller.

Figure 19. Centrifugal Impeller Shroud Assembly.

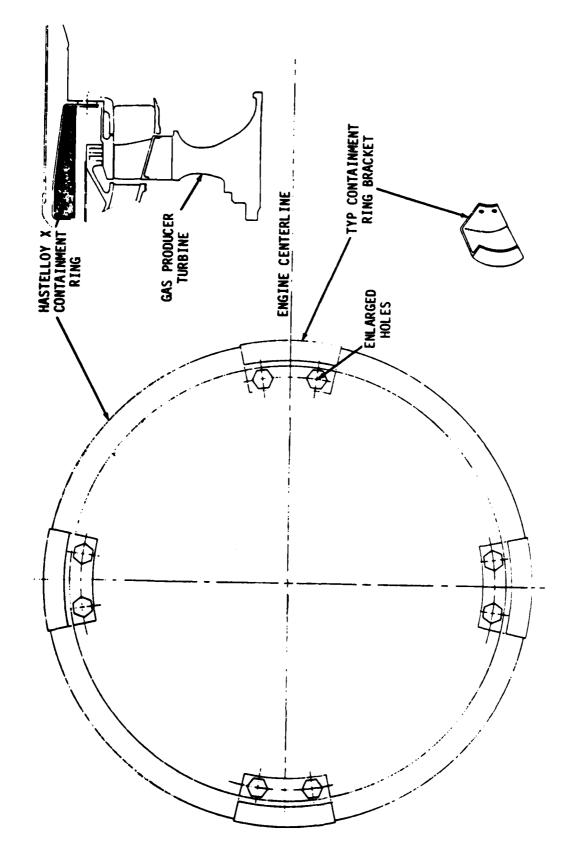
Figure 20. Gas Producer Containment Ring Assembly.

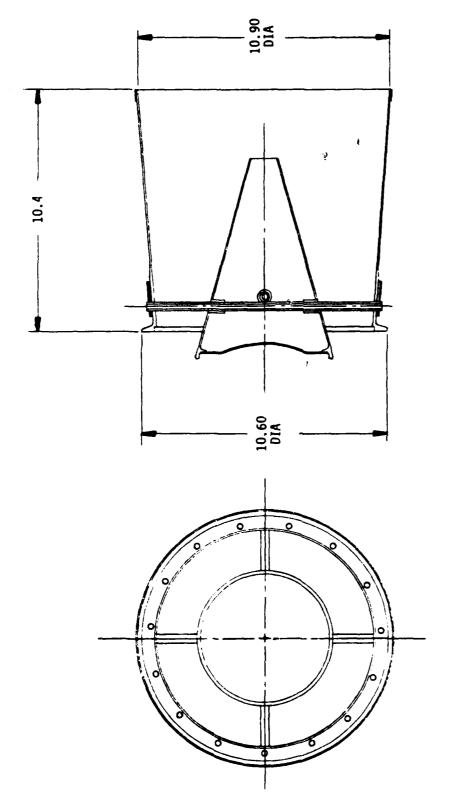
Figure 23. Exhaust Nozzle Assembly.

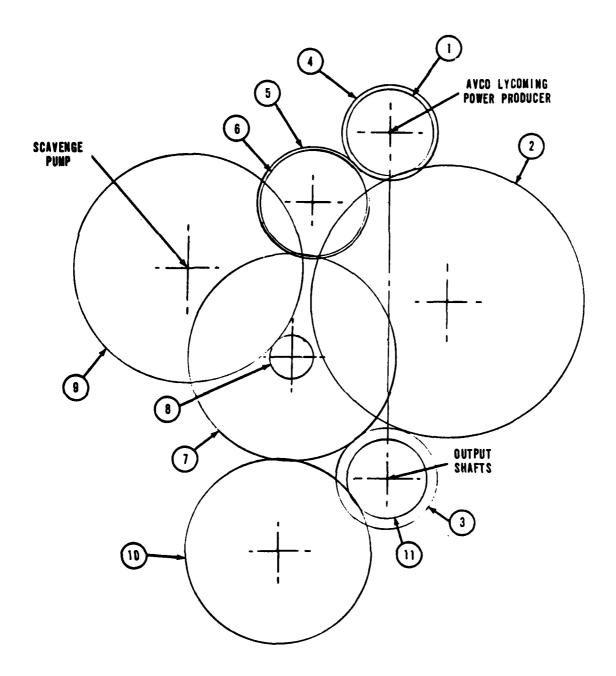
The adapter gearbox provides the interface between the Avco Lycoming high-performance power producer and the Sundstrand accessory gearbox. Separate power and accessory gear trains are provided within the gearbox to produce the proper speed and direction of rotational inputs to the accessory gearbox.

Figure 30. Adapter Gearbox Gear Schematic - Power and Accessory Train.

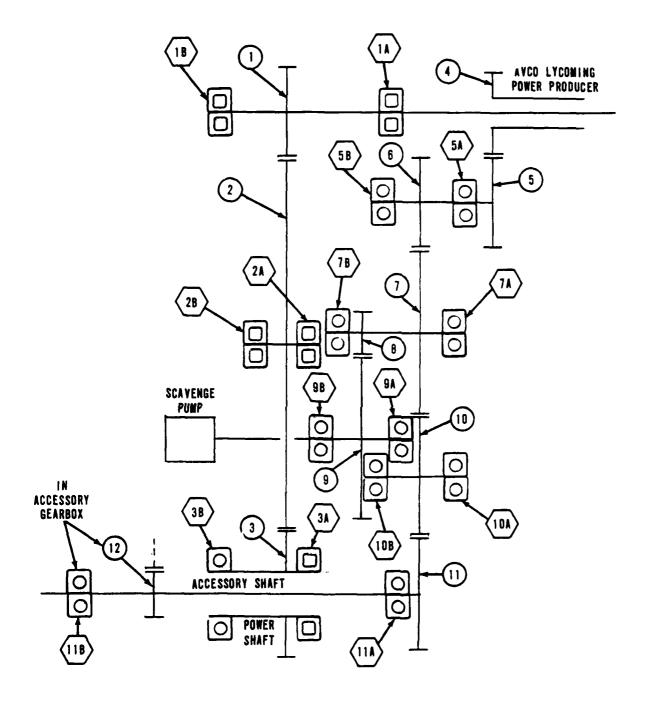
Figure 31. Adapter Gearbox Bearing Schematic.

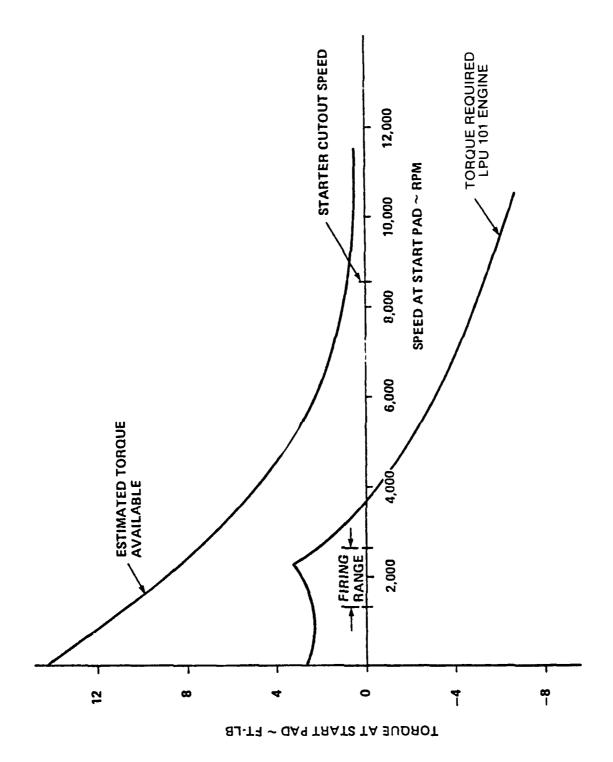
Figure 32 shows the HPAPU torque required for starting and the available starter motor torque at sea level standard-day conditions. Sundstrand experience with this starter in a similar application had produced more than 80 successful APU starts without incident.

Figure 32. HPAPU Start Characteristics - Tam = 590F.

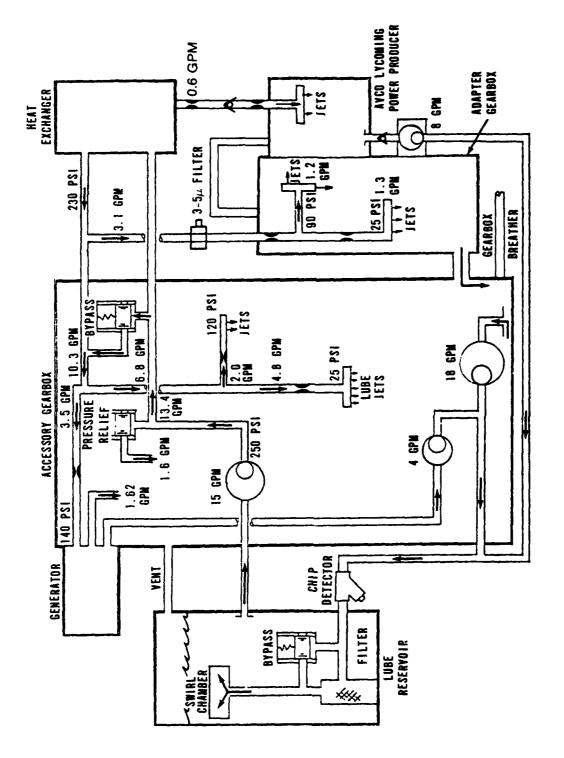
The reservoir is also equipped with a pressure fill port, a gravity fill port, and a differential pressure indicator.

Figure 33. HPAPU Lubrication System.

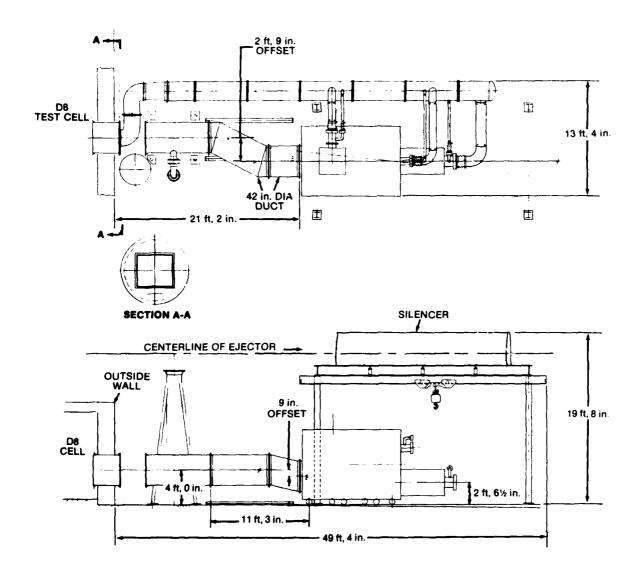
Figure 35. Area Arrangement of Altitude Facility and Test Equipment.

The ejector was operated at a steady-state inlet condition with both the engine inlet and chamber air inlet valves modulated to obtain the proper pressure conditions at the engine. To achieve the correct thermal environment, tempered air was ducted to cell D8 (inlet plenum) from the facility refrigeration plant.

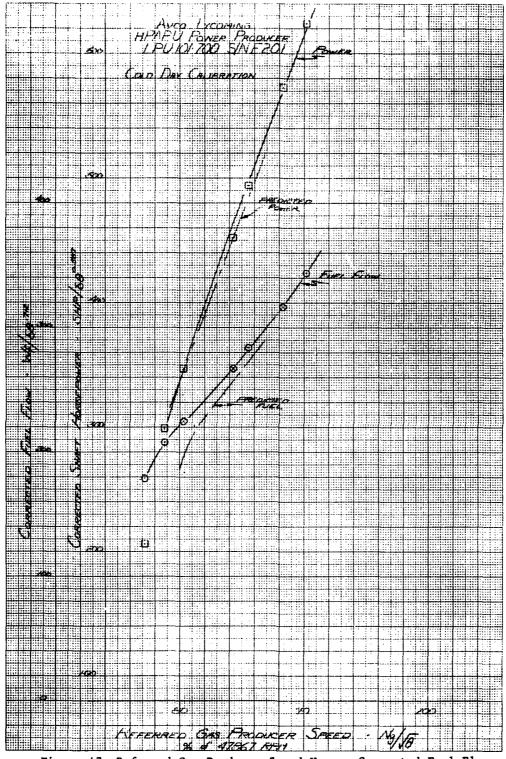
Results of the -65°F calibration are presented in Figures 47 and 48. The data were analyzed by assuming a total pressure at the engine inlet plane. This total pressure was derived from the actual logged inlet nozzle static pressure versus an assumed mass flow static pressure. The maximum correction was approximately 6 to 7 inches H<sub>2</sub>O at full power. The data were further corroborated by a posttest sea level standard condition. This calibration was corrected by -65°F inlet temperature and is presented on Figures 47 and 48 as predicted data.

Figure 47. Referred Gas Producer Speed Versus Corrected Fuel Flow and Corrected Shaft Horsepower - Cold Day.

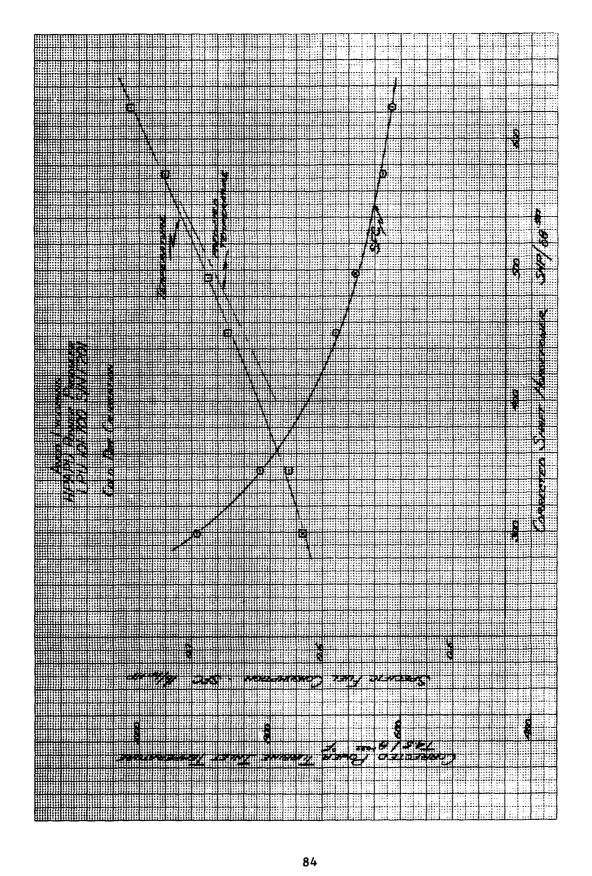
Figure 48. Corrected Shaft Horsepower Versus Corrected Power Turbine Inlet Temperature and Specific Fuel Consumption - Cold Day.

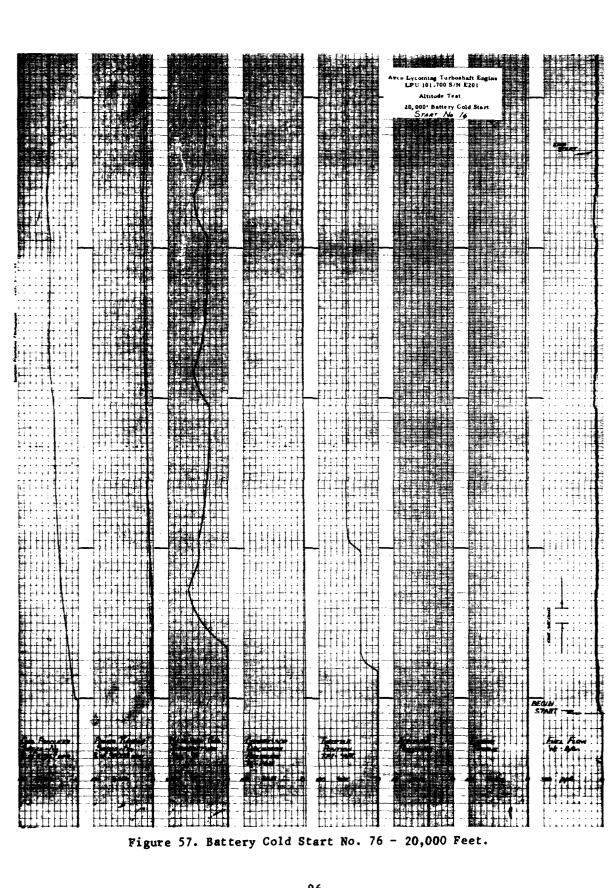
Oscillographic records of representative 10,000- and 20,000-foot starts are presented in Figures 56 and 57. Table 12 presents a synopsis of the test results.

Figure 57. Battery Cold Start No. 76 - 20,000 Feet.

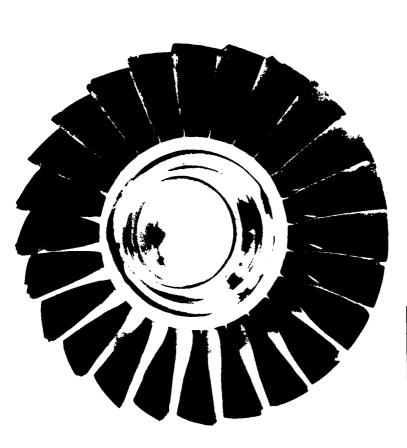
Figure 62. Axial Compressor Rotor with Foreign Object Damage (F.O.D.).

Before delivery of the systems to the Air Force, both power producers were disassembled for inspection. There was foreign object damage in the compressor section of the power producer from the first HPAPU. The axial compressor and diffuser were replaced. Remaining discrepancies on both power producers were minor. The two systems were rebuilt, tested, and shipped.

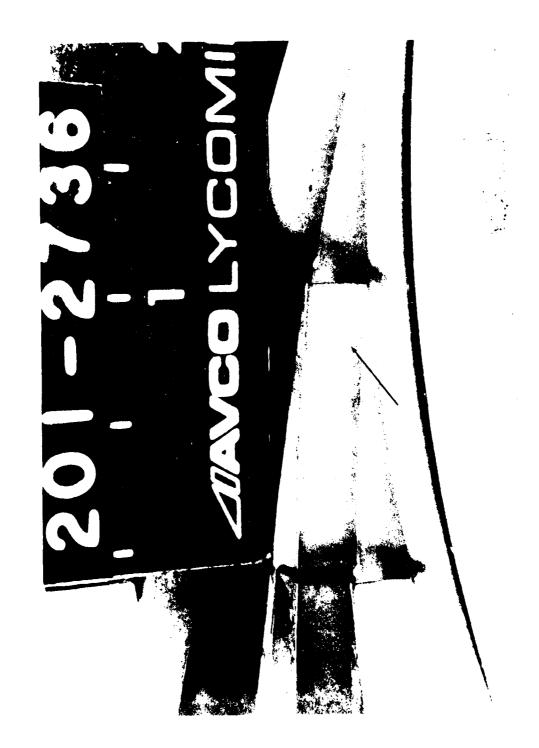
Figure 63. Diffuser Blade (Arrow Shows Leading Edge Crack).

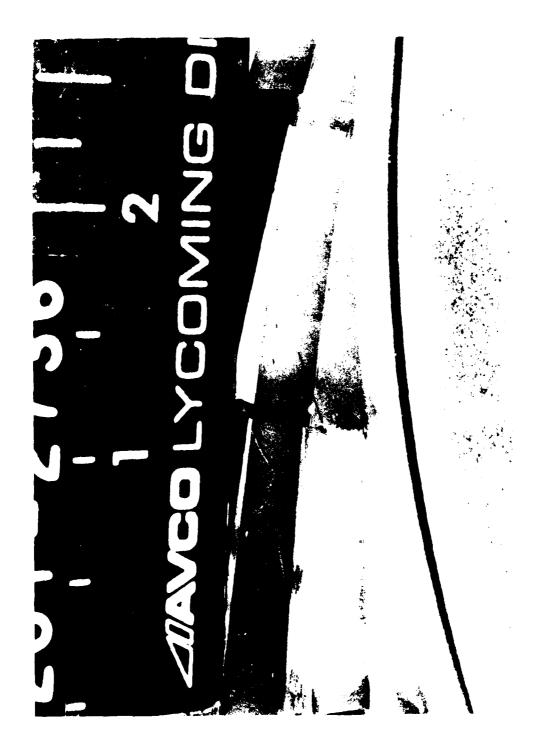
Figure 64. Diffuser Blade (Arrow Shows Foreign Object Damage (F.O.D.)).

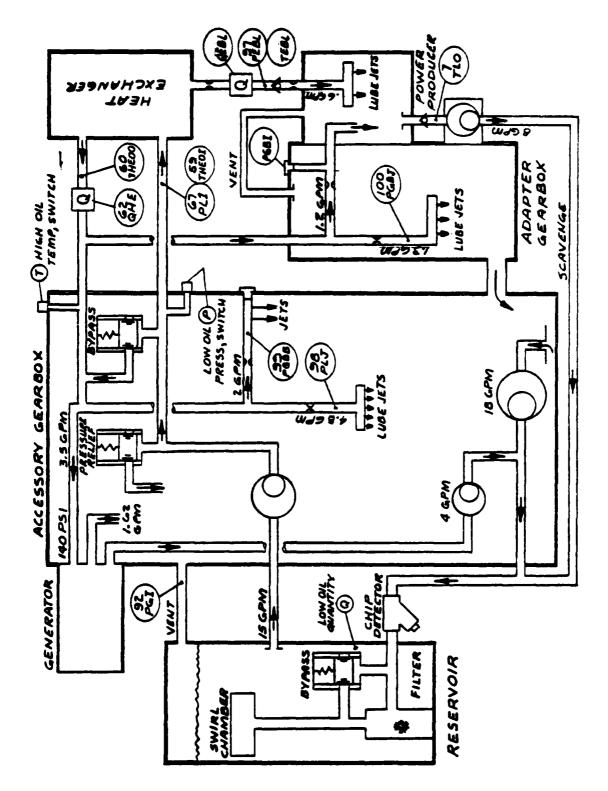
The lubrication system for the HPAPU Demonstrator used during testing is schematically depicted by Figure 76. Lubrication system data were recorded in accordance with the listing of Table 15.

Figure 76. HPAPU Lube Schematic.

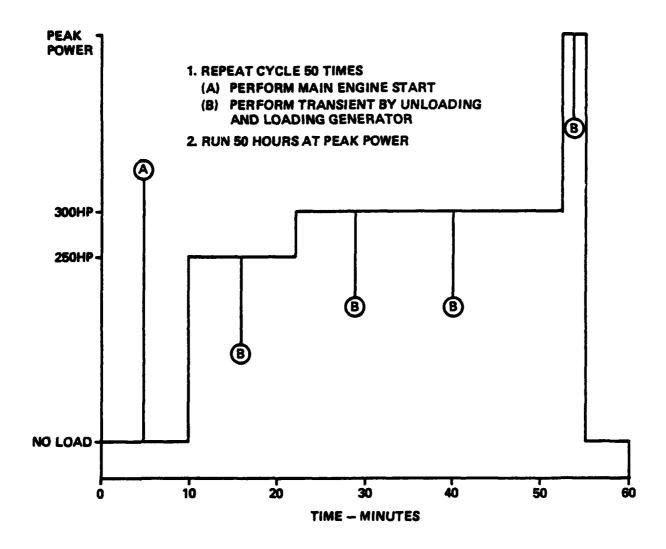
Figure 77. HPAPU Endurance Cycle.

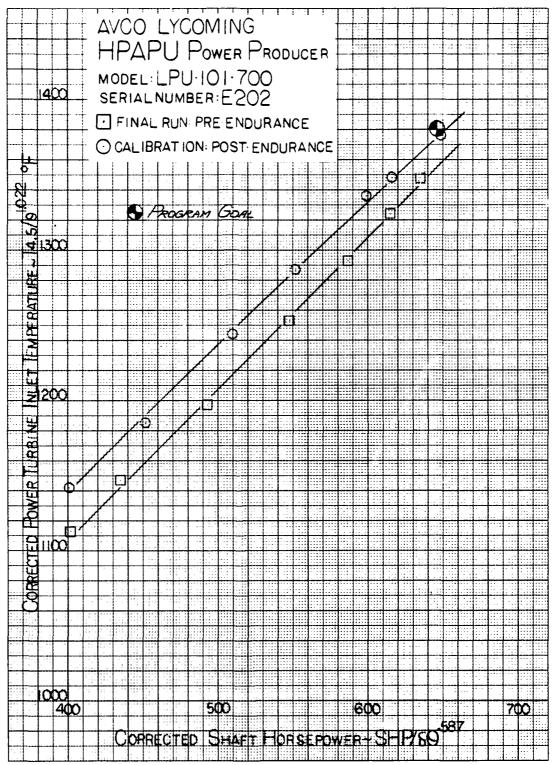
Figure 79. Pre- and Post-Endurance Calibration - Corrected Power Turbine
Temperature Versus Corrected Shaft Horsepower

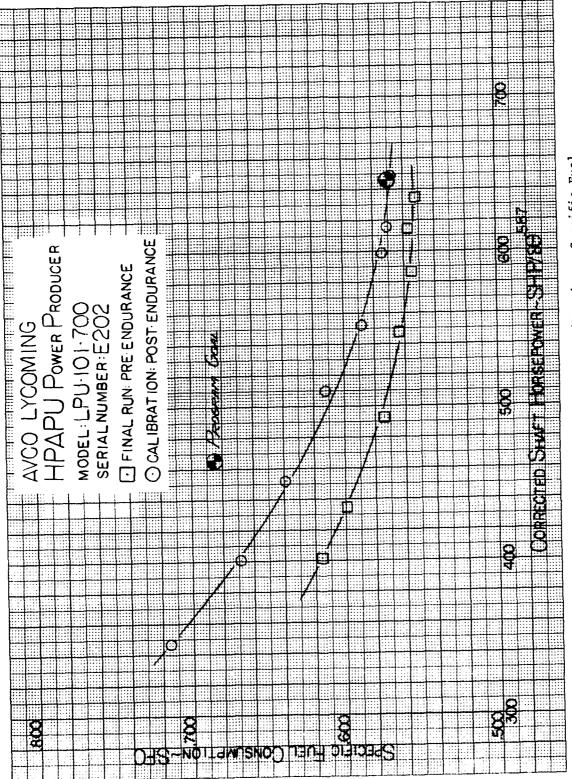
Figure 80. Pre- and Post-Endurance Calibration - Specific Fuel Consumption Versus Corrected Shaft Horsepower
